Technical Report CHL-99-19  
September 1999

# **DMS: Diagnostic Modeling System**

## **Report 2**

### **Reduction of Sediment Shoaling of the Entrance Channel at East Pass, Florida**

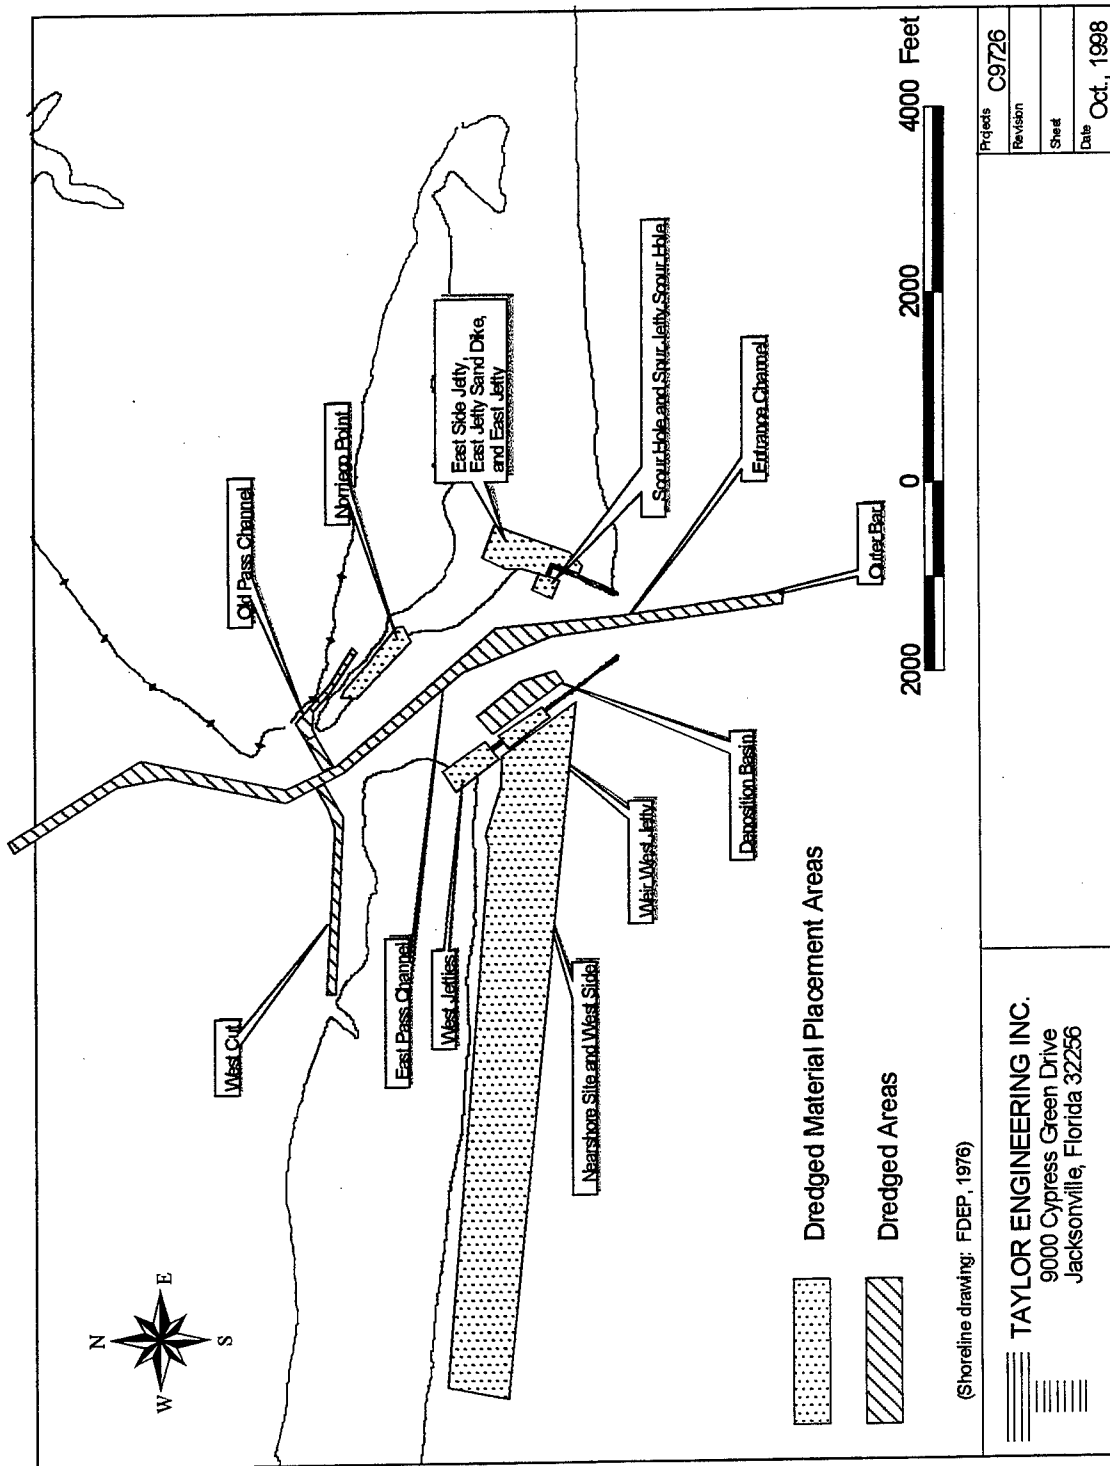
Figure 2. Dredging locations and placement sites

Between 1931 and 1995, dredging removed approximately 4 million cubic yards of sediment — about 64,000 cu yd/year — from the project channel. Figure 2 illustrates the locations of the dredge sites and disposal placement areas that encompass all dredging activity at East Pass. Figures 3 and 4 categorize the dredged and placed volumes by site. Some of the designations required considerable estimation. As is usually the case, the dredging records (especially early records) were incomplete. Figures 3 and 4 show that dredging frequency has decreased, while the magnitude of volume dredged has increased. This trend is explained by advances in economic dredging practice. Notably, before 1964, Open Water/Surf Zone designation characterized much of the dredge-material placement. Figure 2 does not denote this area because no reliable record exists of the actual placements. Also, during its early history, side-cast dredges were used to maintain the channel. Thus, the placement area depended on the maintenance location. Table 1 summarizes the dredging activity at East Pass throughout its history.

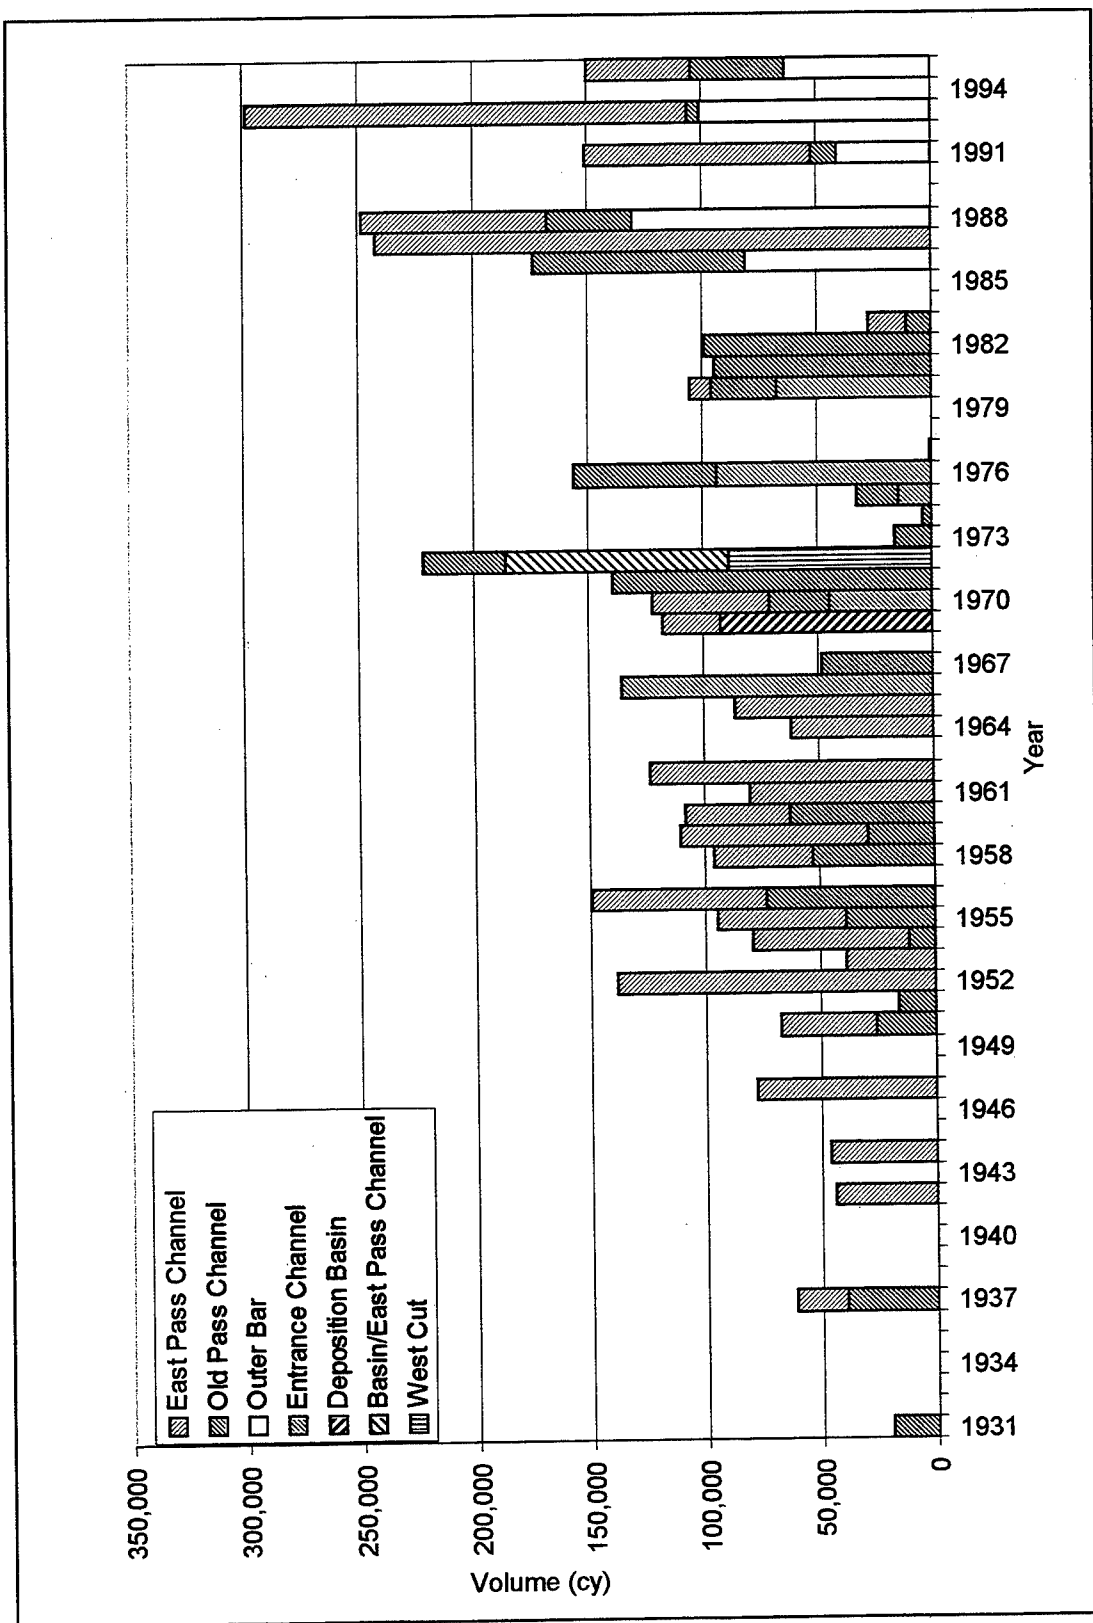
Figure 3. Dredged volumes by site

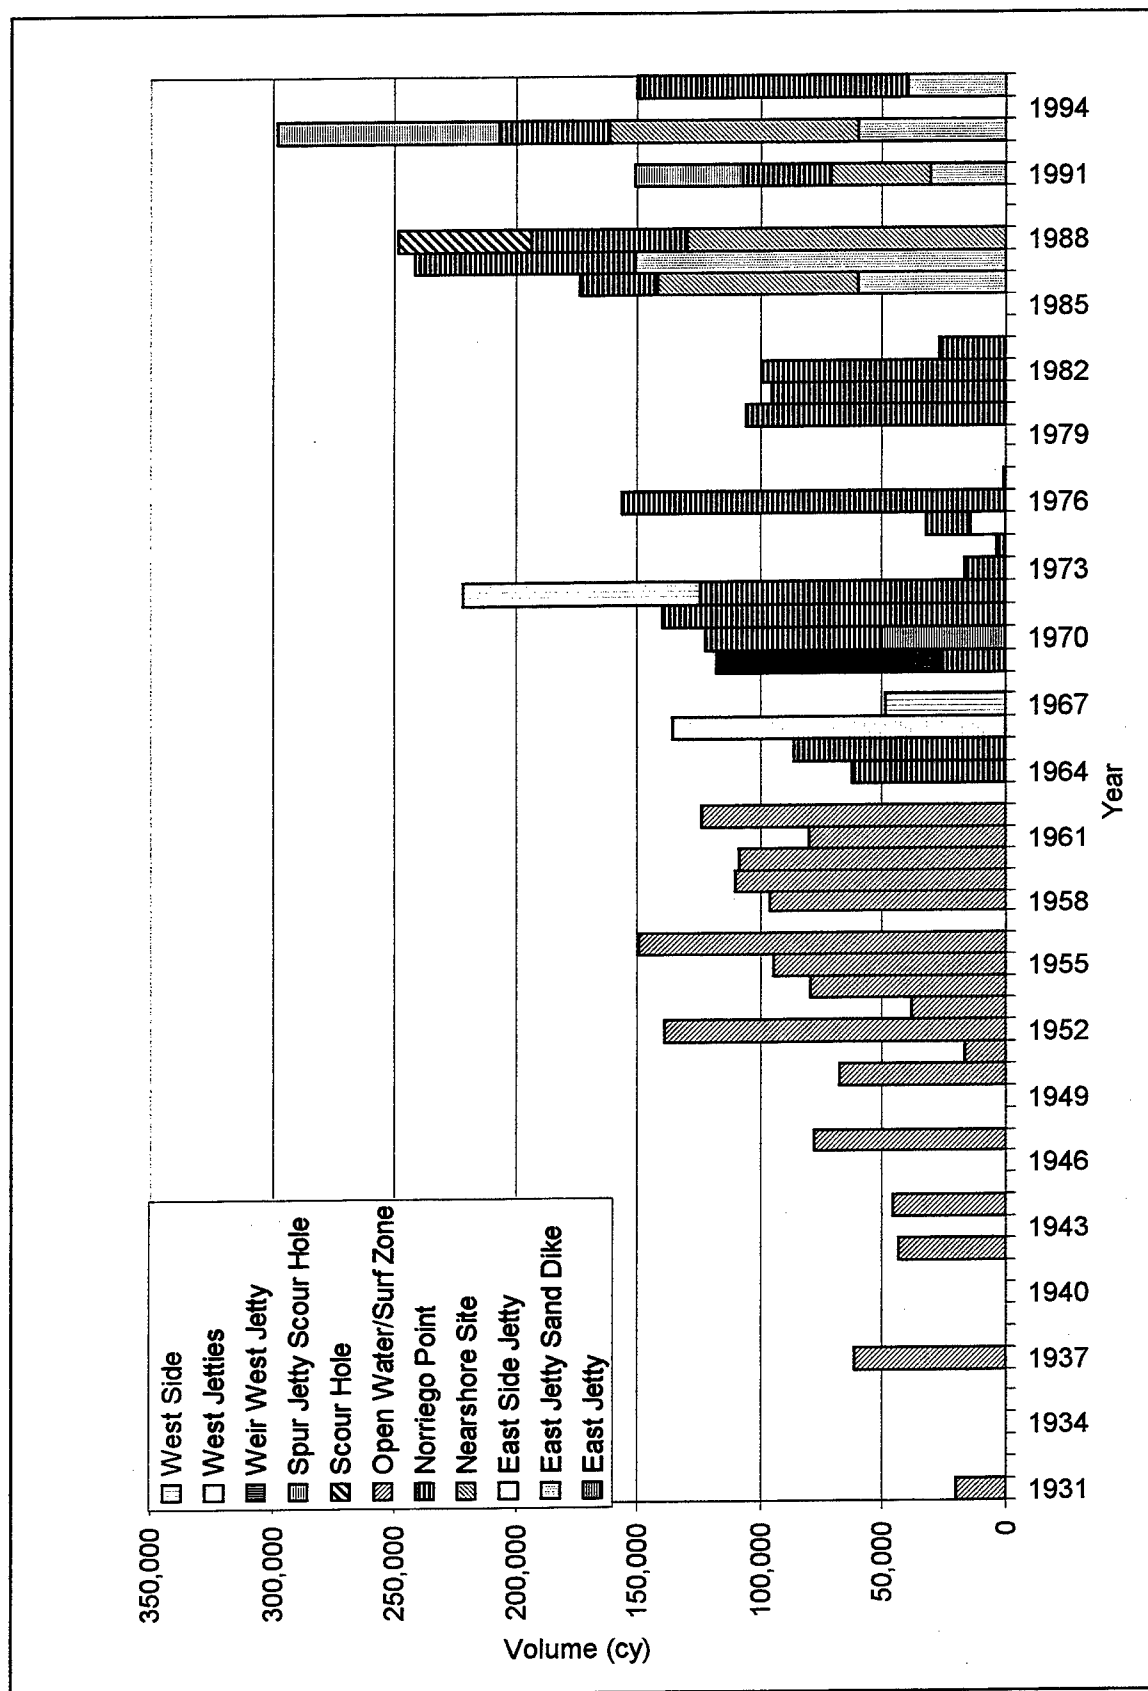
Figure 4. Dredge-material placement by site

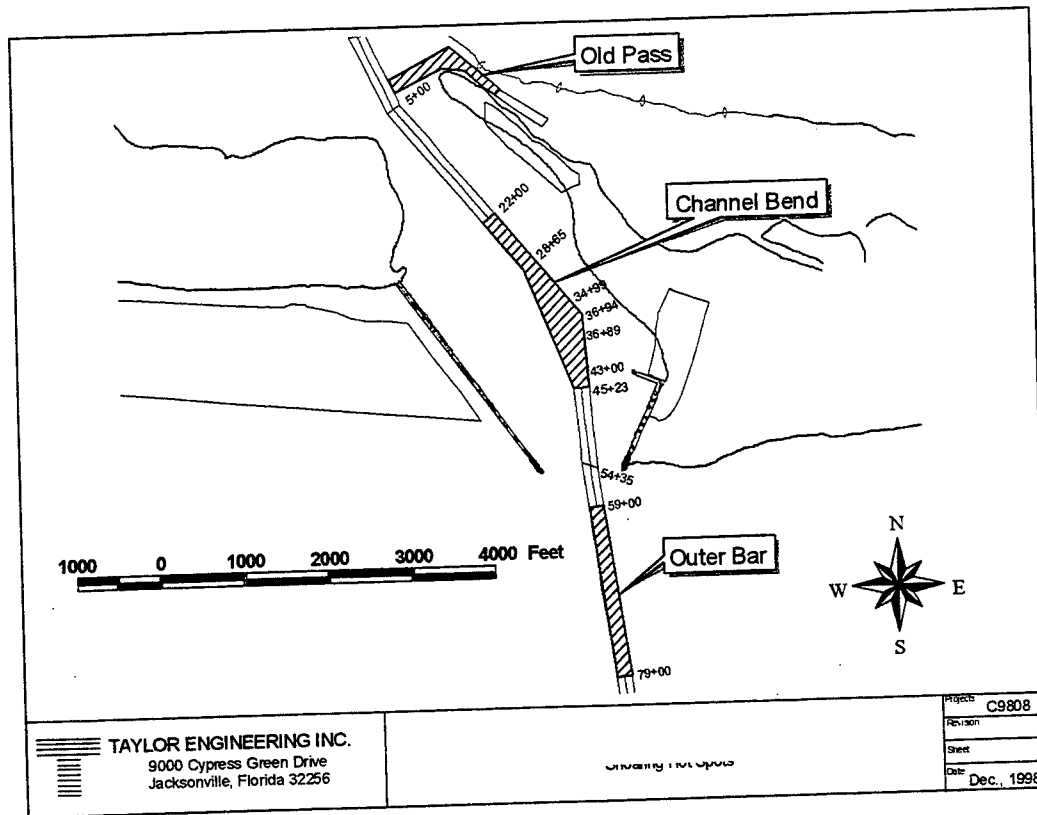
Figure 5. Shoaling hot spots at East Pass

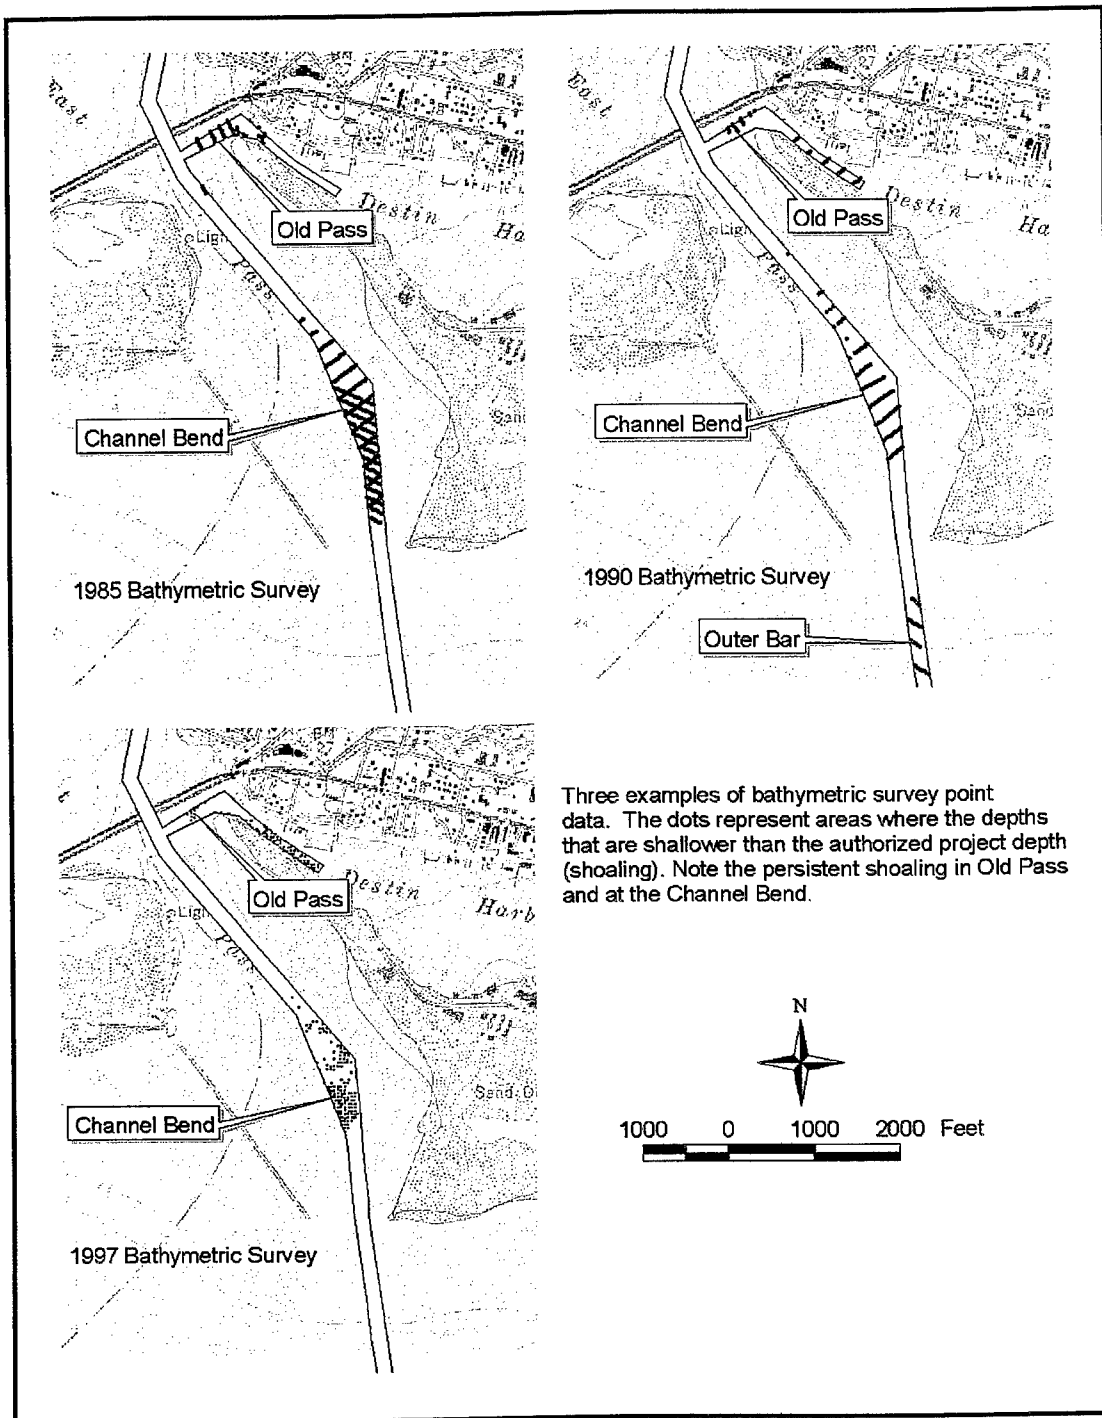
Figure 7. Bathymetric survey comparisons, 1985, 1990, 1997

fathometer surveying techniques. The 1997 survey comes from the SHOALS LIDAR program using airborne laser mapping techniques. Obviously, the data density is significantly increased in the 1997 survey; however, the user can see discernible and repeating patterns in each survey. Notably, the Old Pass entrance channel to Destin Harbor and the Channel Bend within East Pass exhibit consistent shoaling patterns over each survey. The 1990 survey also indicates shoaling within the authorized channel as the channel passes across the ebb-tidal shoal. Once problem areas are identified, they can be compared with the examples given in the DMS-Manual. Further analyses should then follow the techniques included in the DMS-Analytical Toolbox to determine the root cause of the shoaling and to examine potential solutions.

With the data assembled in one place, the user can first make some simple observations. First, areas of persistent shoaling become easy to identify. Although personnel with extensive experience on a given project are likely familiar with such areas, documentation in a graphical format helps to clarify and quantify the problem. Figure 7 shows data from bathymetric surveys of East Pass in 1985, 1990, and 1997. Each of these surveys covers areas outside the authorized channels. For clarity, the data have been filtered to display only those falling within the authorized channels. The first two surveys involved standard

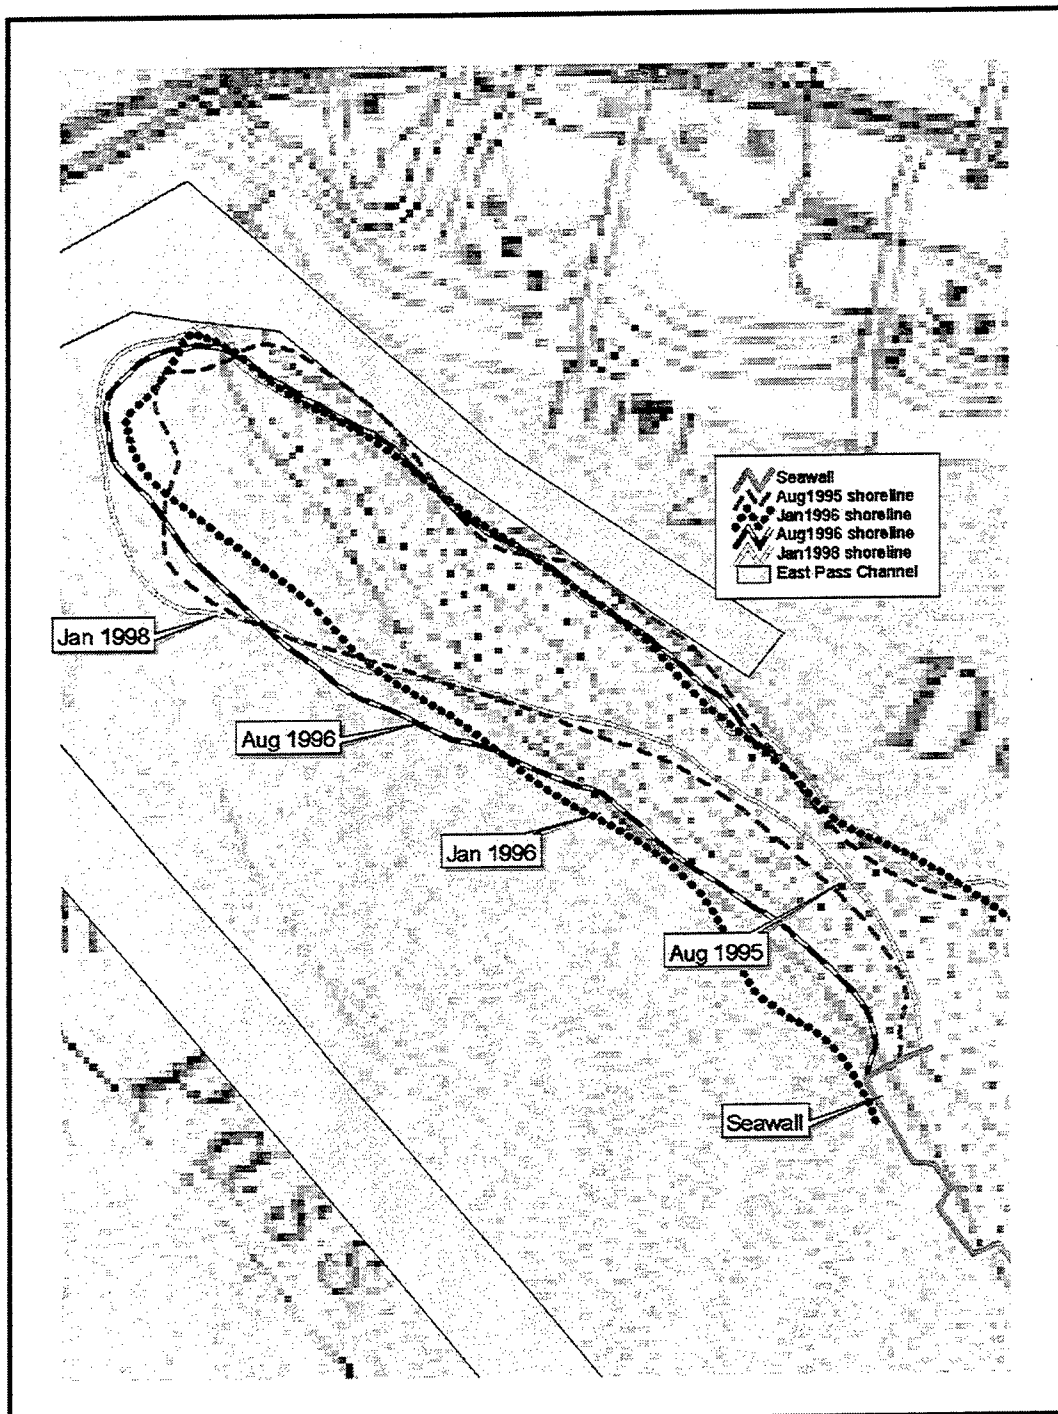
Figure 8. Norriego Point shoreline evolution

A particular area of concern to the East Pass project engineers is Norriego Point, one of several sites serving for disposal of the dredged material taken from the authorized channels. Norriego Point shelters Destin Harbor from offshore waves that propagate through the jetties into East Pass. Sand historically erodes from Norriego Point into the channels. To document the erosion of Norriego Point, Figure 8 shows four shoreline surveys taken over a 30-month period. The August 1995 shoreline shows conditions before the impact of Hurricane Opal. The January 1996 survey shows conditions following emergency Post-Opal dredging operations that placed sand on Norriego Point. The August 1996 survey shows some of the initial evolution of the shoreline position following placement. Finally, the January 1998 survey shows that the shoreline again approximated 1995 conditions. Chapters 3 and 4 investigate possible contributions that the eroding Norriego Point may have to the shoaling in the authorized channels.

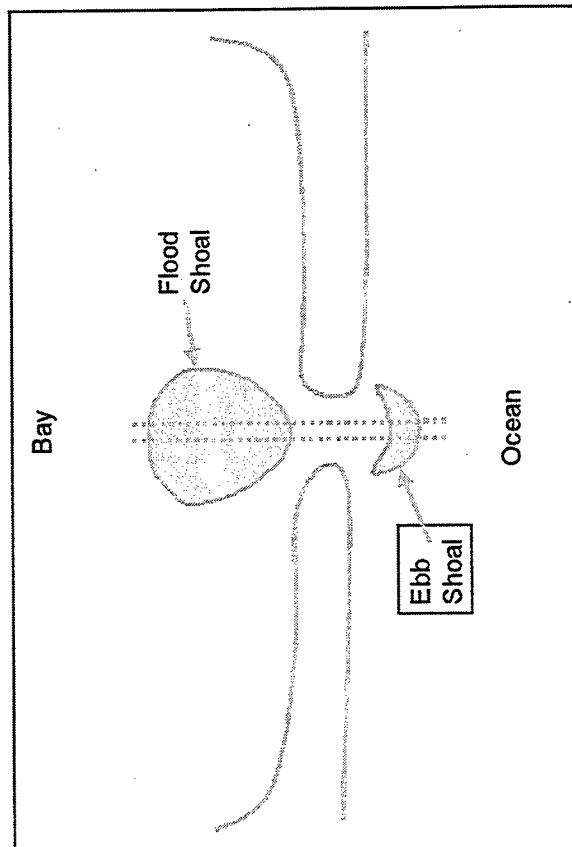
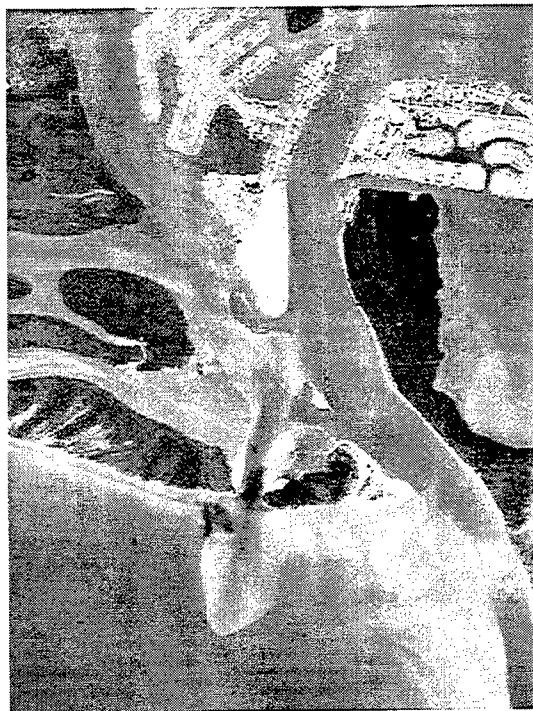
**Description:** A crescent- or box-shaped shoal that forms at the seaward end of a tidal inlet. Shape of this shoal depends on the area's wave climate.

**Processes:** Wave-induced sediment transport (littoral drift) interrupted by the inlet is directed seaward by the ebb tide. Sediment settles out in the region of relative calm away from the strong currents near the inlet mouth. The decrease in velocity results from the depth-dependent horizontal spreading of the ebb jet.

Figure 9. Example page of the DMS-Manual (*Horizontal Expansions: Expansion into Ocean – Ebb Tidal Shoal*)

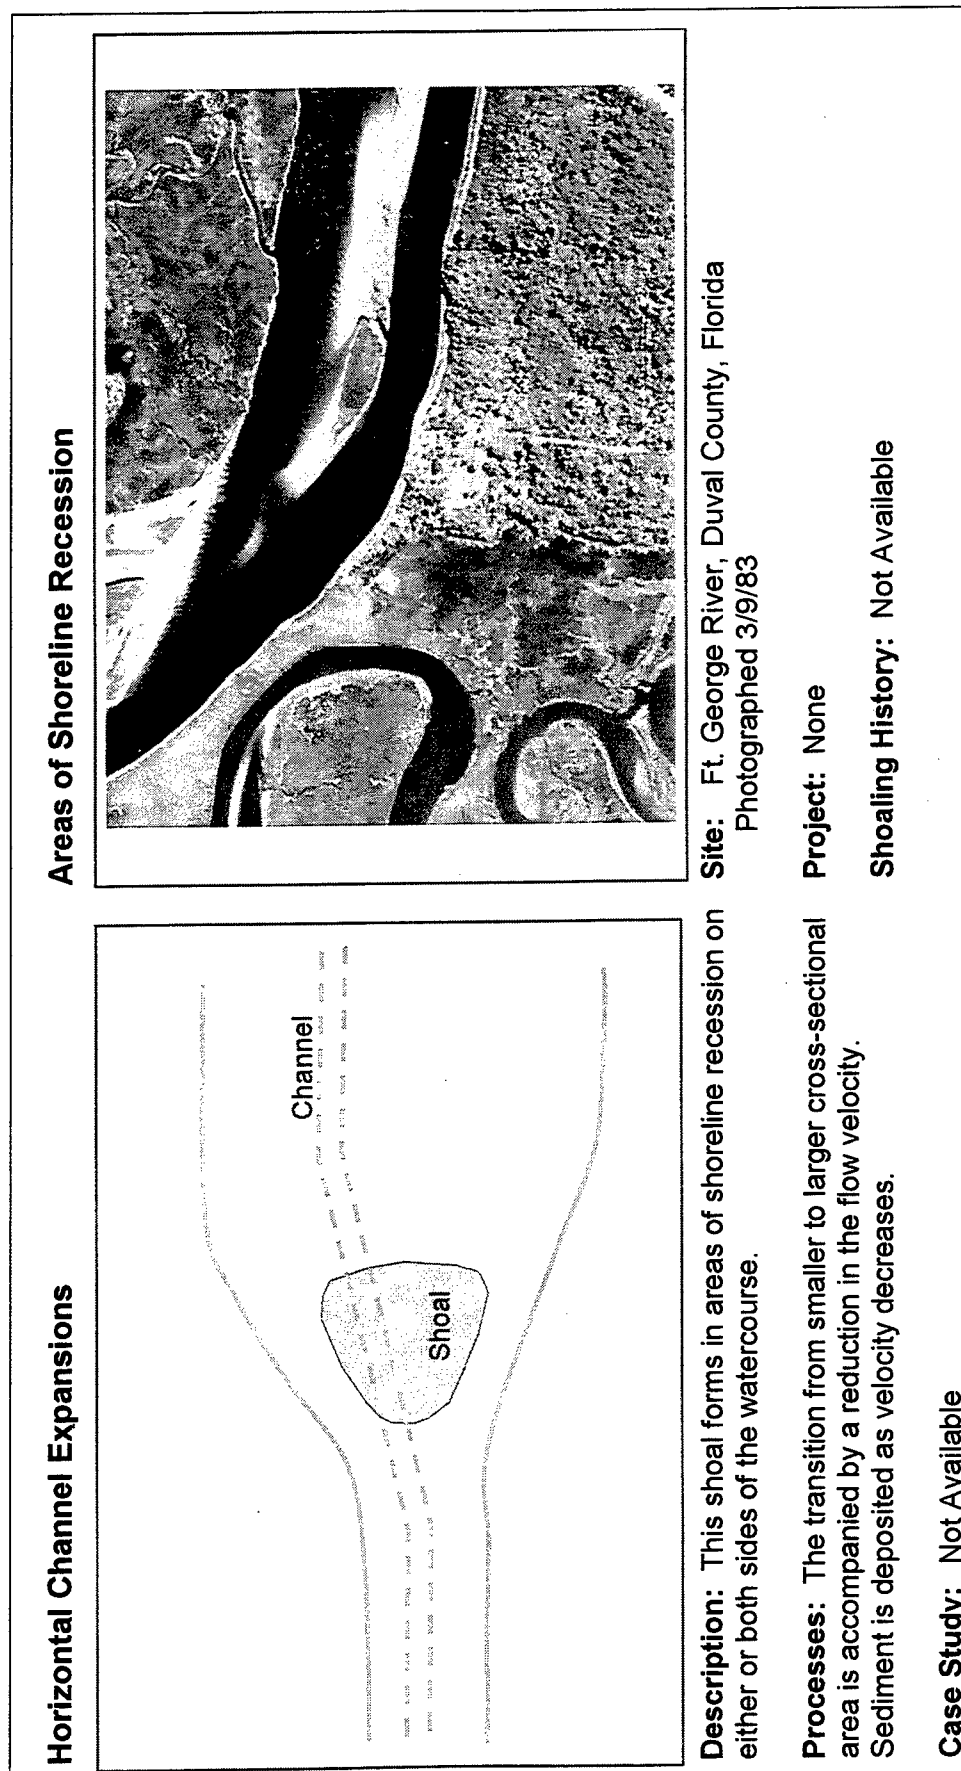
Figure 10. Example page of the DMS-Manual (*Horizontal Expansions: Areas of Shoreline Recession*)

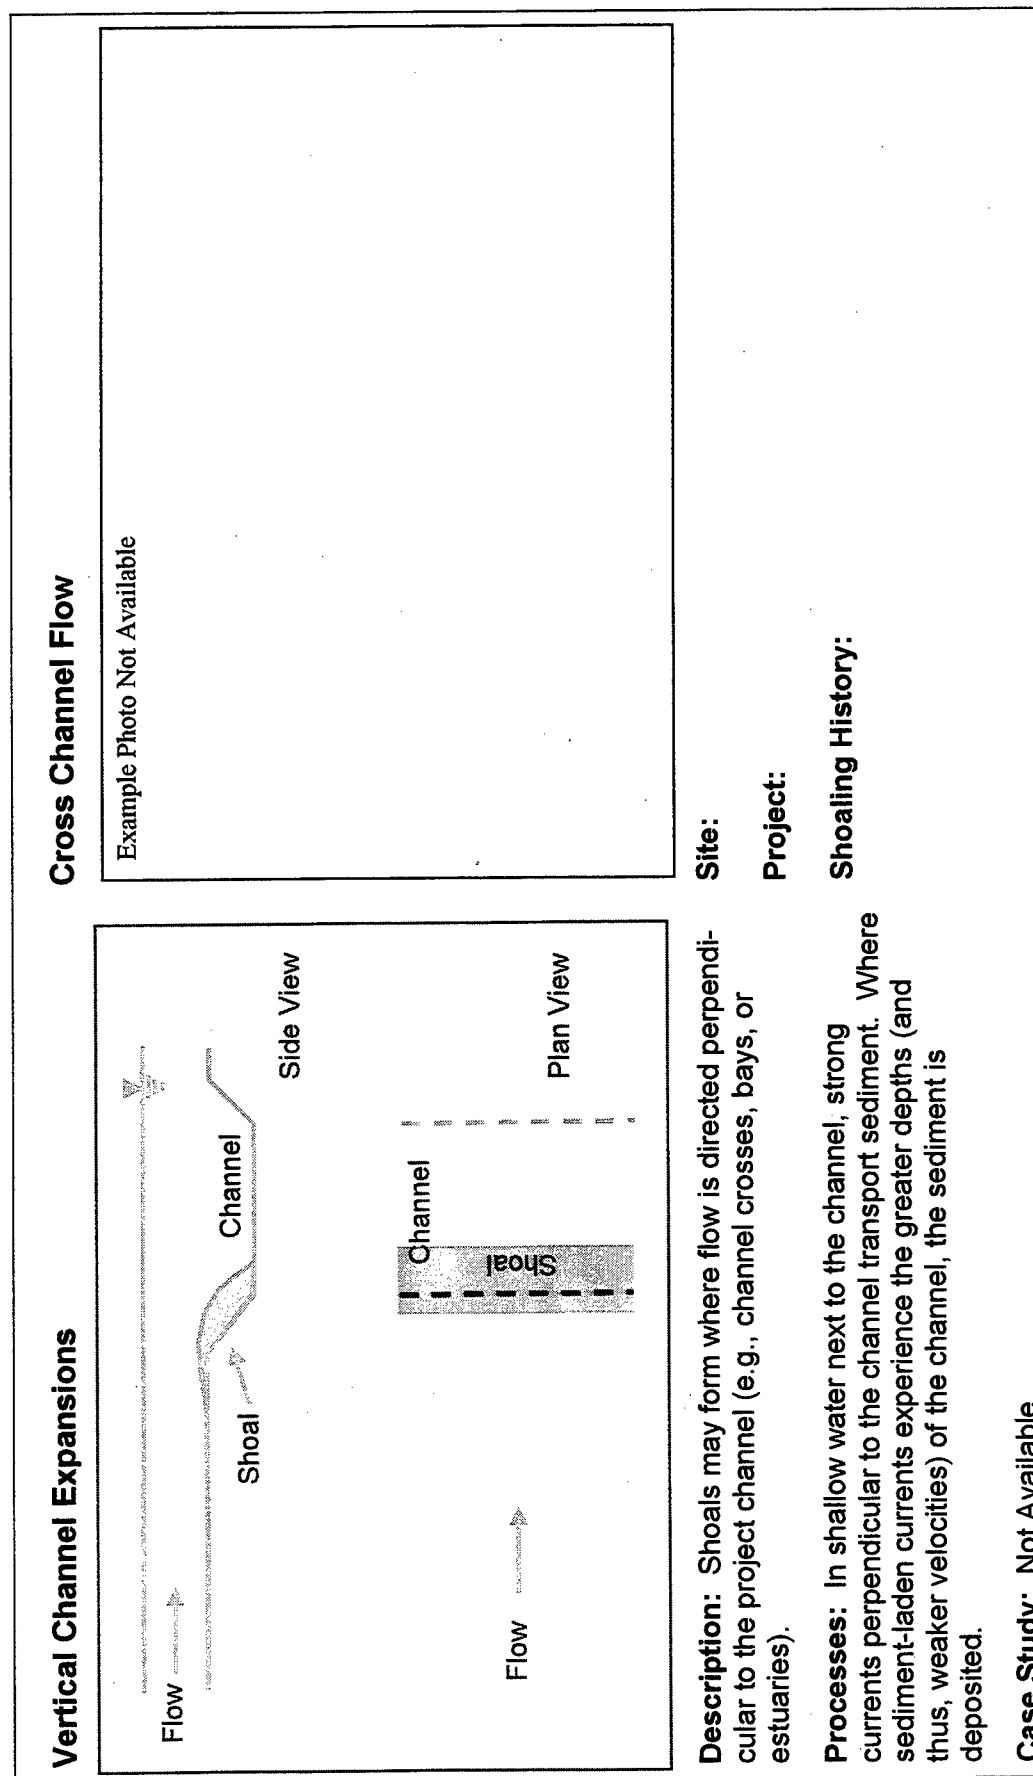
Figure 11. Example page of the DMS-Manual (*Vertical Expansions: Cross Channel Flow*)

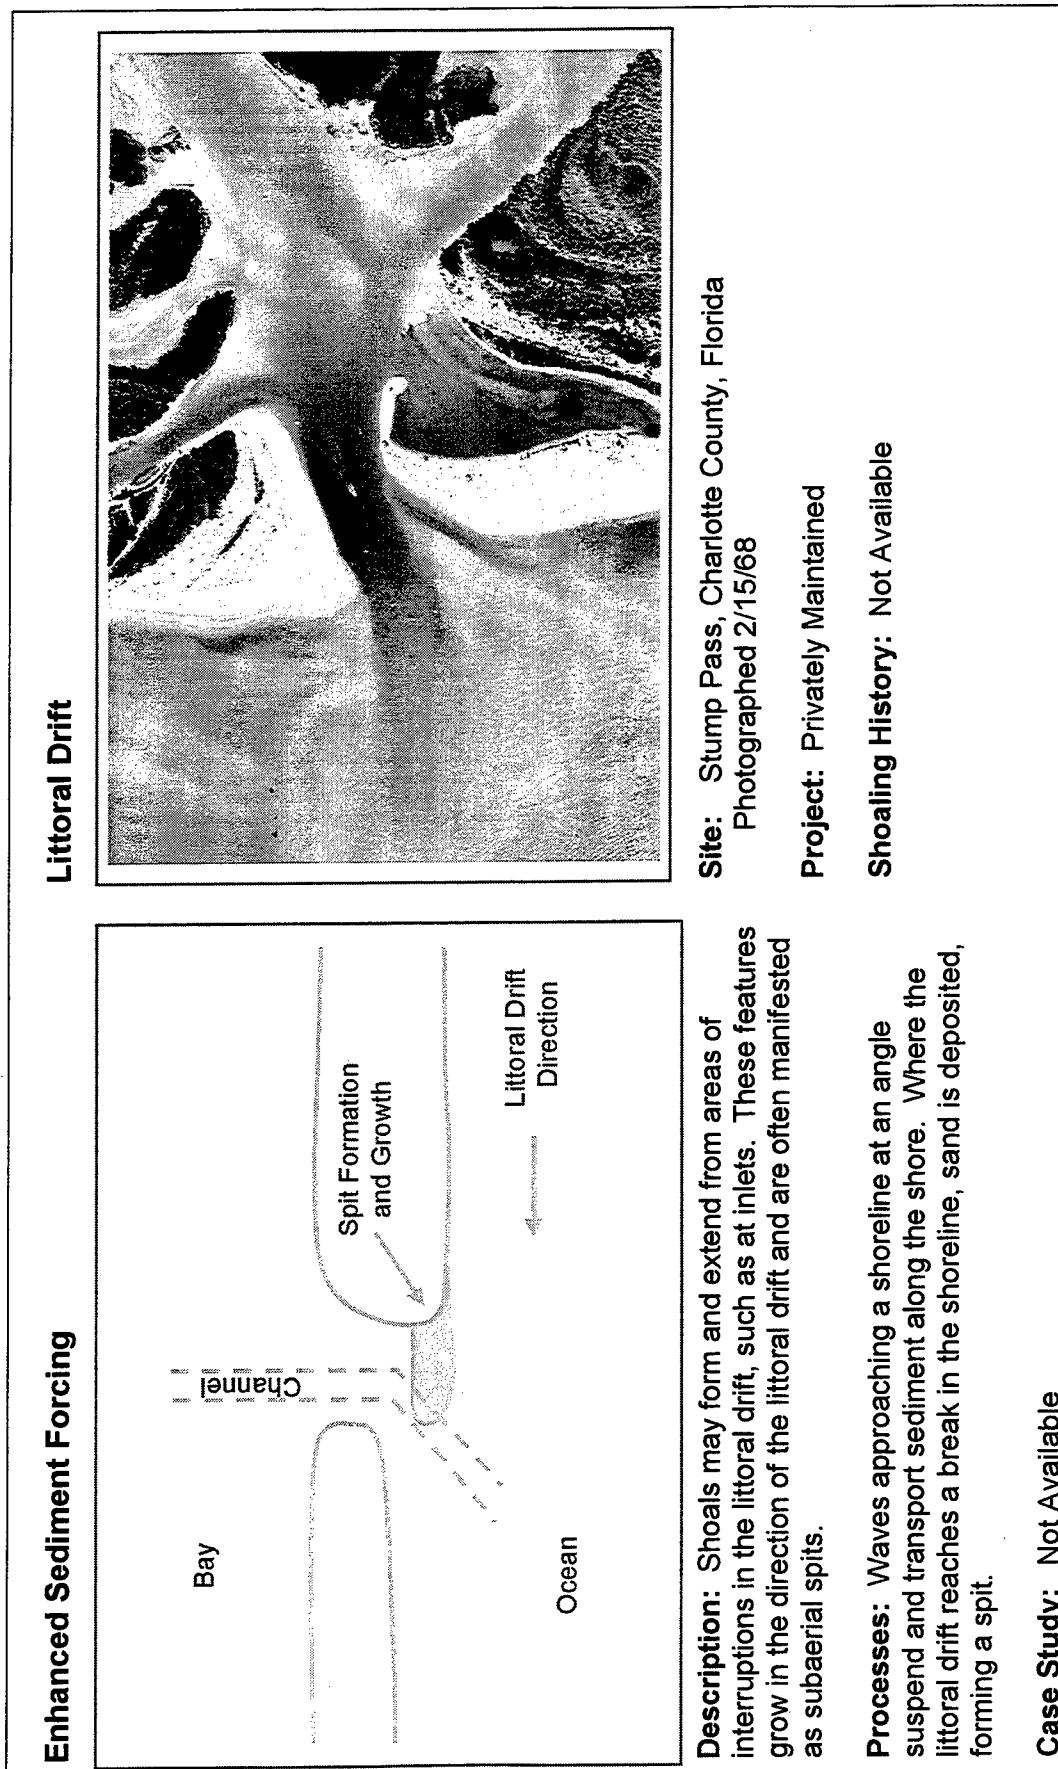
Figure 12. Example page of the DMS-Manual (*Enhanced Sediment Forcing: Littoral Drift*)

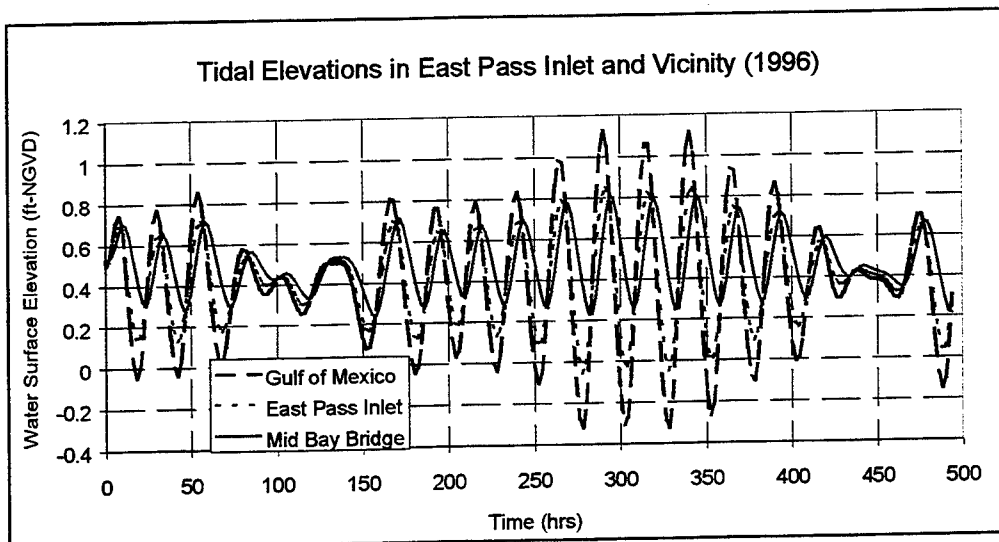
Figure 13. Example of time-series plot

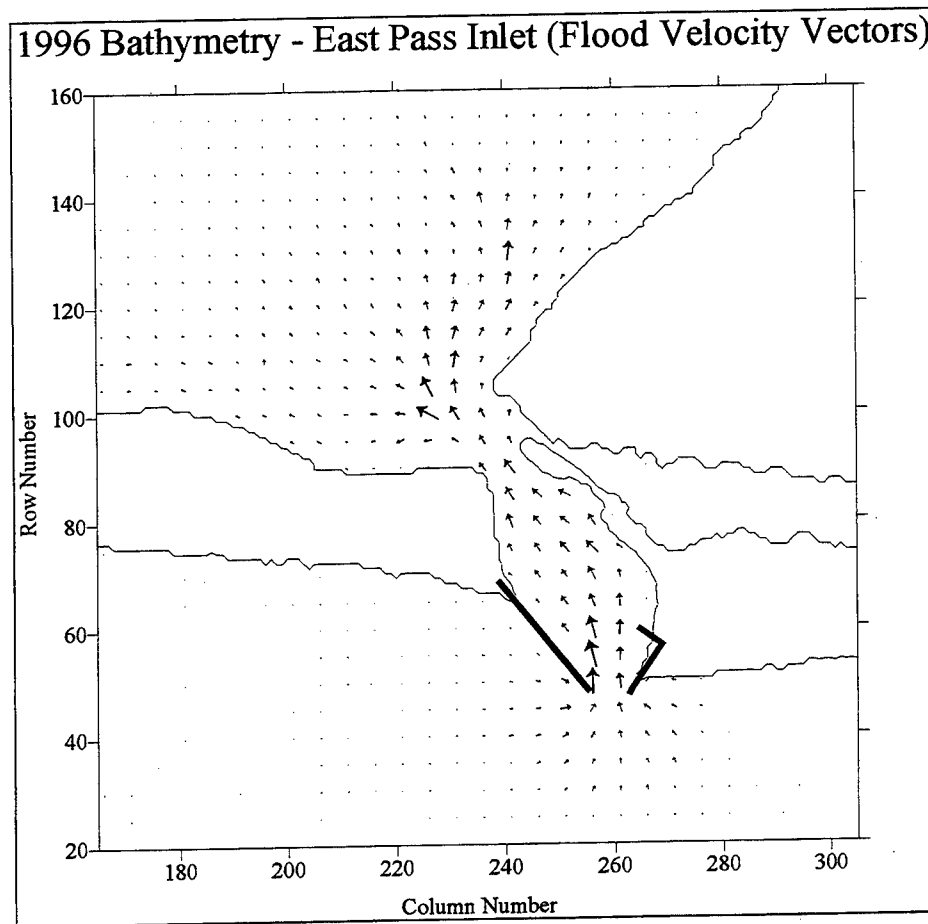
Figure 14. Example of two-dimensional velocity vector plot

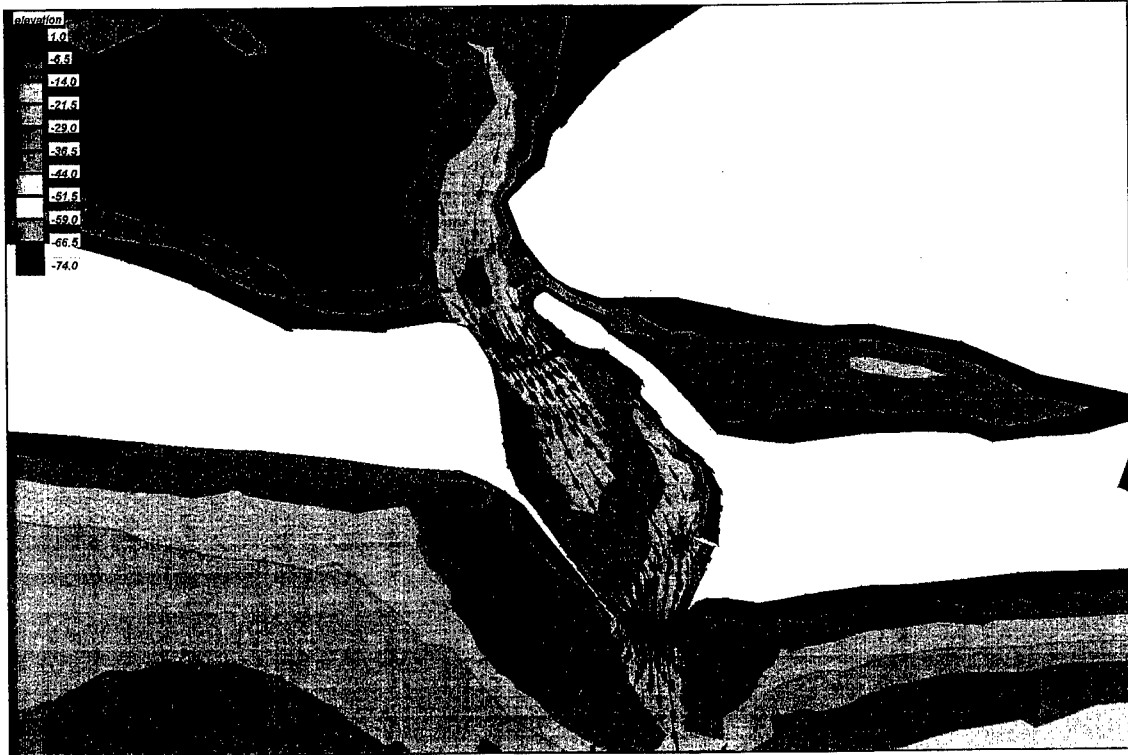
Figure 15. Example of false-color bathymetry with velocity vector overlay

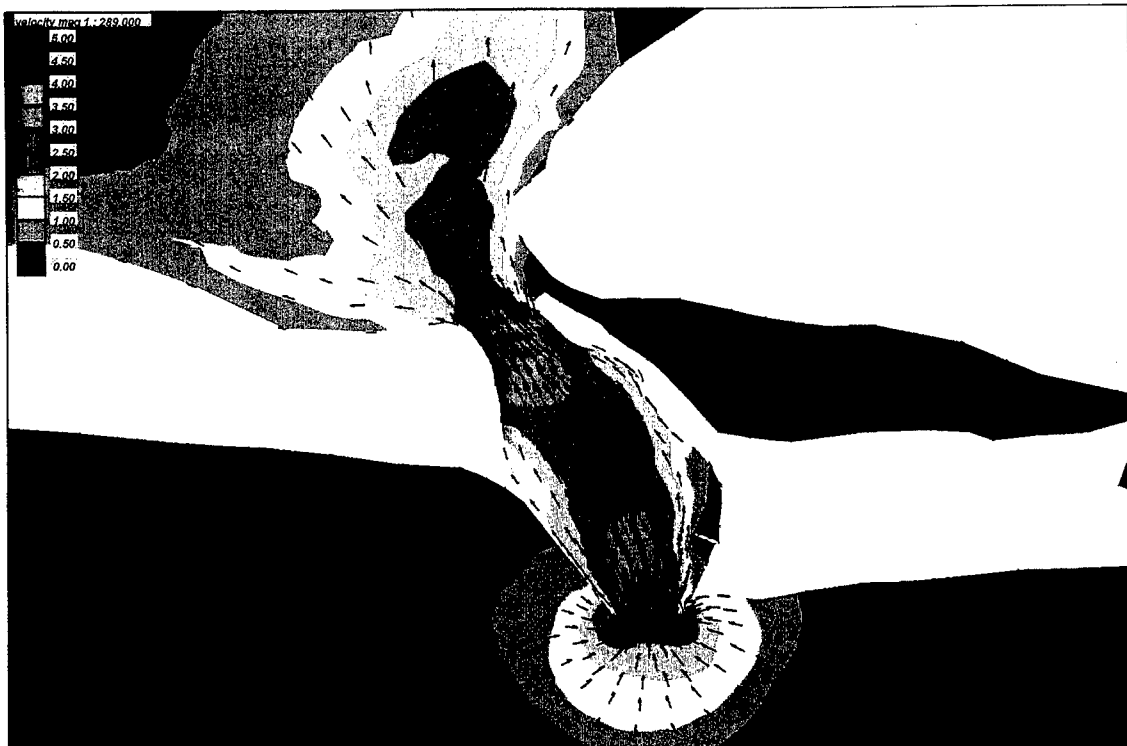
Figure 16. Example of false-color velocity magnitude contour plot with velocity vector overlay

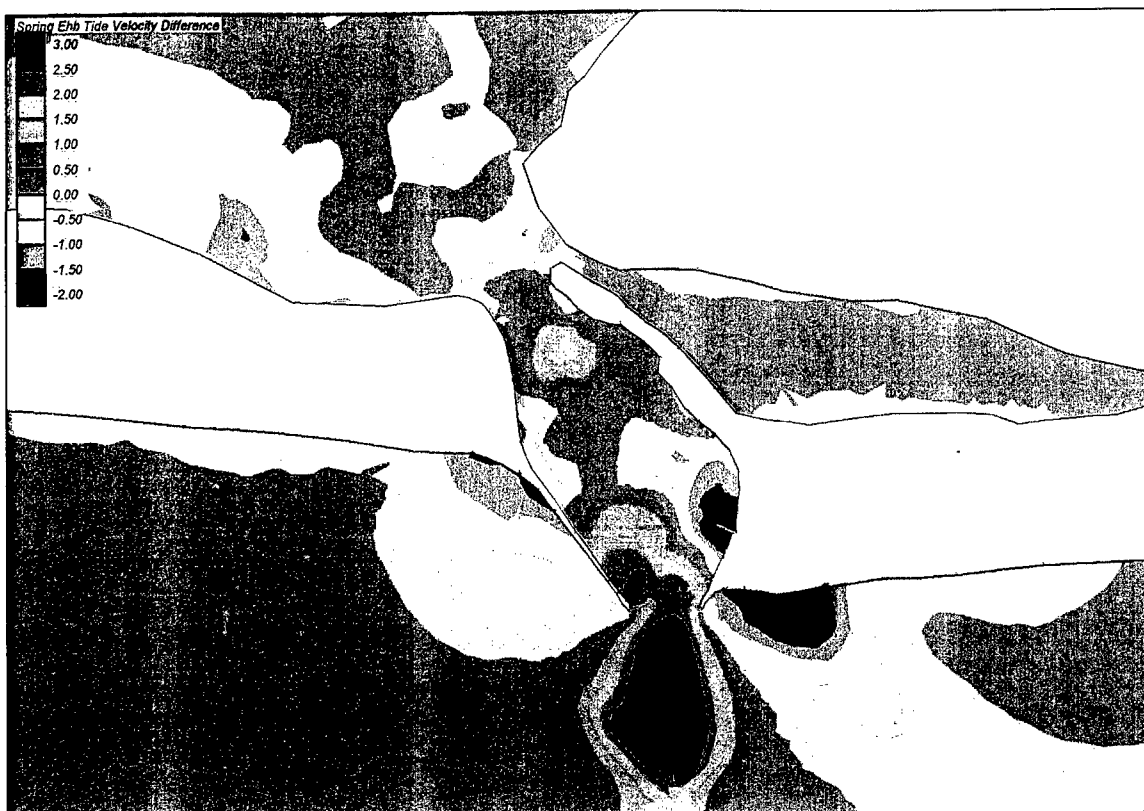
In addition to these types of plots, graphics contours showing differences in two solution sets can provide informative comparisons. For example, Figure 17 was generated to investigate the change induced by jetty construction by plotting the difference in velocity magnitude for hydrodynamic model simulations of a 1947 bathymetry (pre-jetty construction) and a 1996 bathymetry (post-jetty construction). The plot shows the difference in spring ebb-tide velocity magnitude. Positive values (towards the blue end of the spectrum) denote increases in velocity magnitude, and negative values (towards the red end) denote decreases. Units are in feet per second.

Figure 17. Example of comparison of solutions

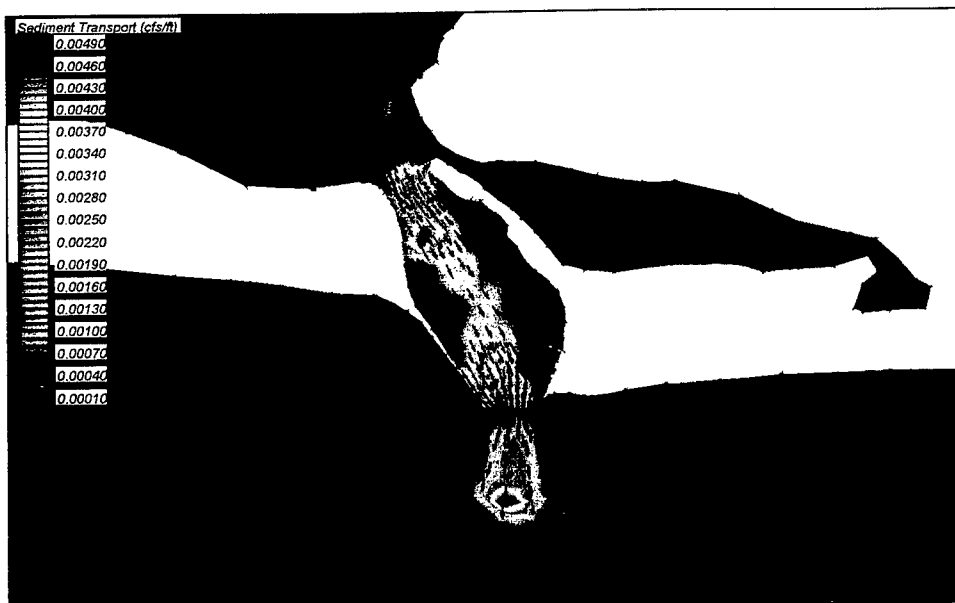
Application of the sediment-transport calculator produces a spatially variable scalar data set (a contour plot) of magnitude of sediment-transport rate. Interpretation of contours of sediment-transport magnitude is often difficult. One must remember that sediment-transport magnitude does not necessarily correlate to erosion or deposition. Erosion and deposition align more closely to the gradients of sediment-transport rate in the flow direction. If, for example, in a specified control volume, the sediment transport entering the volume exceeds the sediment transport leaving the volume, then most likely, the volume will contain deposition. The appropriate analogy is that of filling a bucket with a hole in the side. If water enters the bucket faster than it comes out the hole, the water level will rise (accretion). If water enters at a slower rate, then the water level will fall (erosion). The most prudent way to interpret these results is to conclude that sediment originates in areas showing sediment transport and moves in the direction of the velocity vectors. Figure 18 illustrates a contour plot of sediment transport overlaid with the water-velocity vectors.

Figure 18. Example of contours of sediment transport
